# *Aloha Home Inspections*

## Property Inspection Report

2121 Ala Wai Blvd. #1702, Honolulu, HI. 96815

Date of Inspection: 2/9/2026

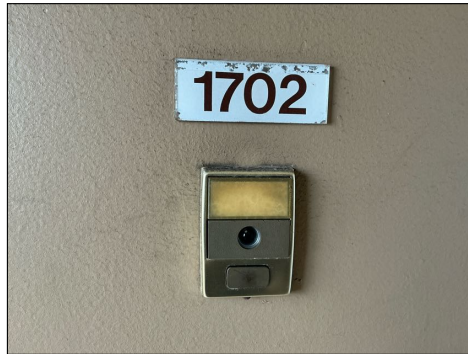
The doorbell is aged, worn & does not function properly. Recommend replacing.

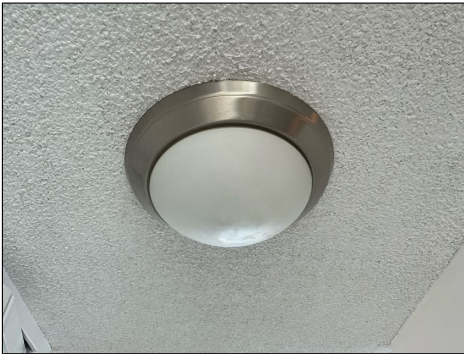
Light fixture does not operate. Possibly bad bulbs or bad fixture. Recommend repair.

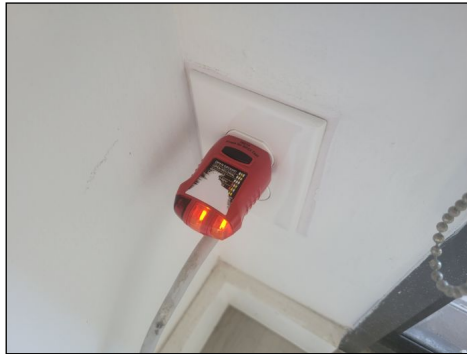
(REVISION.01APR2026) The outlets have been replaced. The outlets were tested & are in good condition.

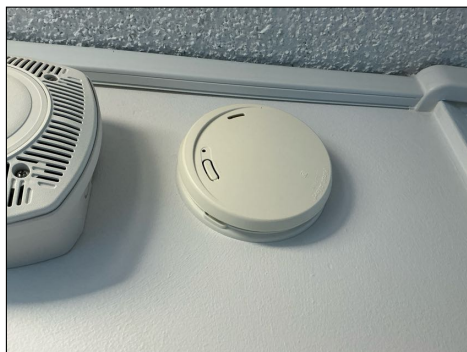
The smoke alarm detector did not work. Possibly bad battery or bad unit. Recommend replacement.

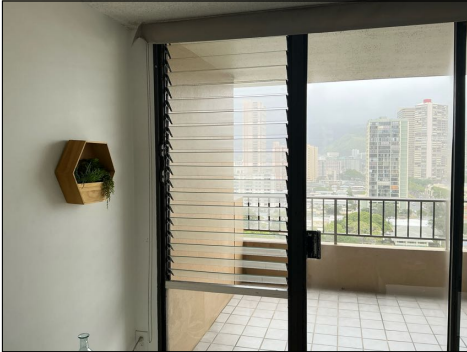
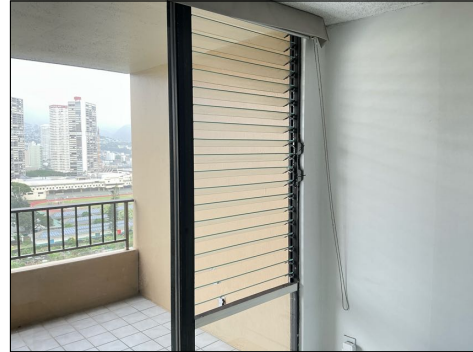
The window should be considered aged & worn. We recommend any necessary maintenance, cleaning & minor repairs to ensure that the windows remain in optimal condition.

Missing window screens. Recommend installing.

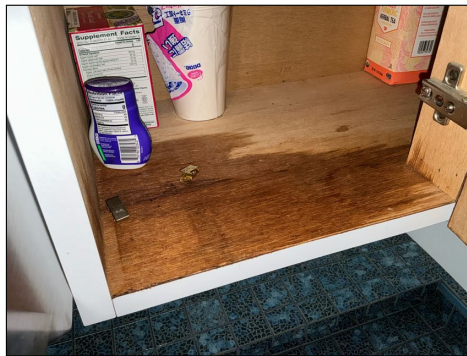
Normal wear and other cosmetic damages observed throughout the cabinets. Recommend repairing or replacing.

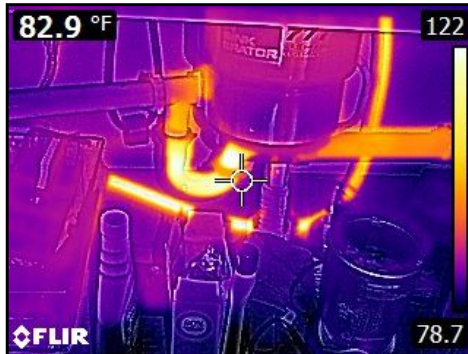
Infrared scan shows dry condition; no leaks.

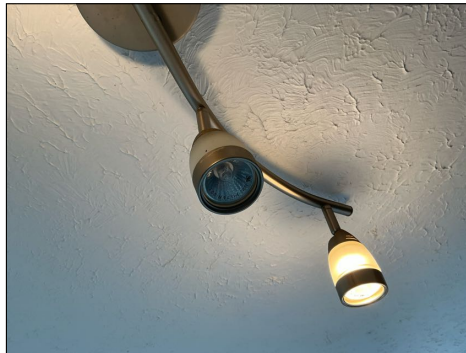
Light fixture does not operate. Possibly bad bulbs or bad fixture. Recommend repair.

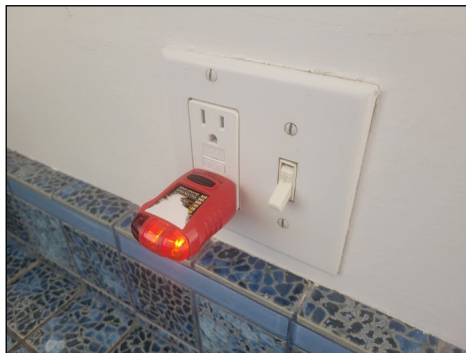
(REVISION.01APR2026) The GFCI outlet has been replaced. The GFCI outlet was tested & is in good condition.

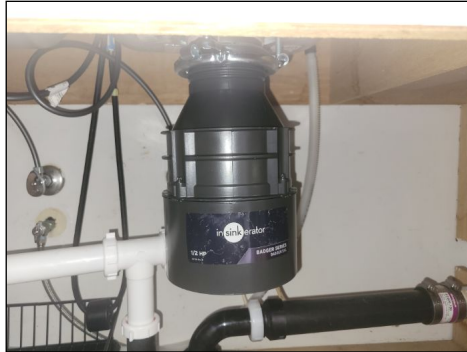
(REVISION.01APR2026) The disposal has been replaced. The disposal is in good condition.

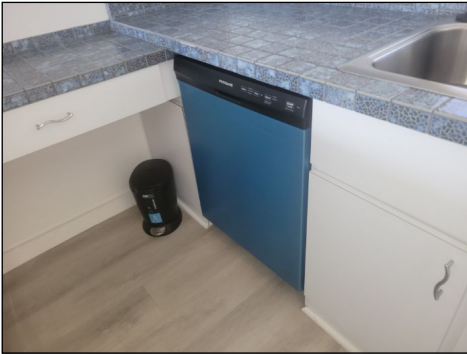
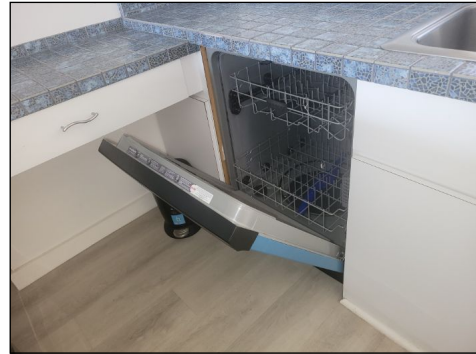
(REVISION.01APR2026) The dishwasher has been replaced. The dishwasher was tested & is in good condition.

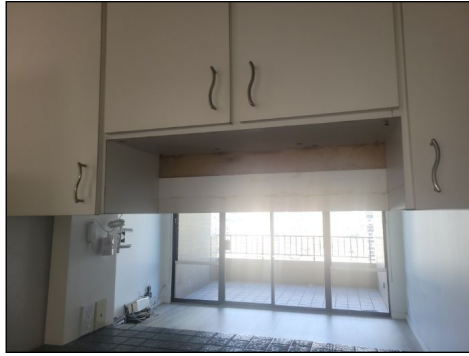
(REVISION.01APR2026) The kitchen vent has been removed.

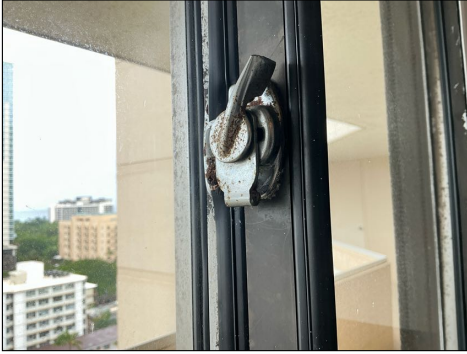
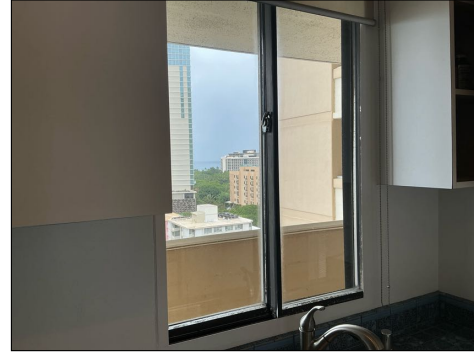
Broken window handles observed. The window should be considered aged than worn. We recommend any necessary maintenance, cleaning & minor repairs to ensure that the windows remain in optimal condition.

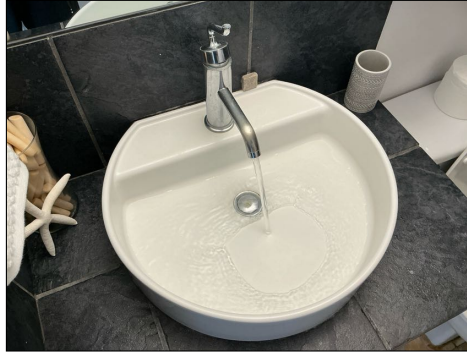
Stopper does not work. Recommend repair.

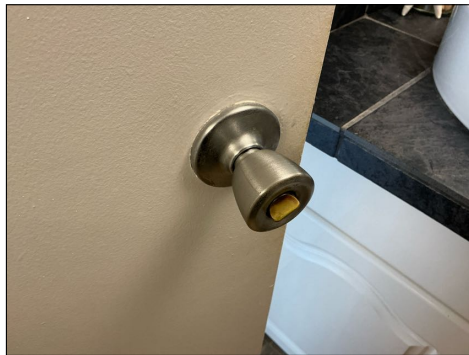
Doorknob does not lock properly. Recommend replacing.

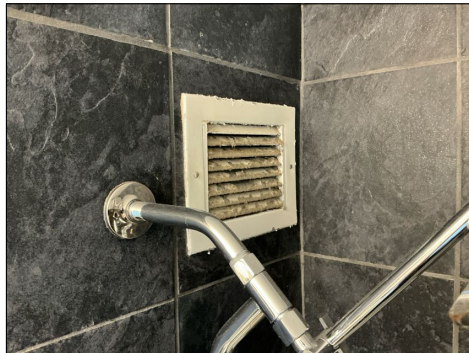
Bath fan did not appear to function properly. The fan appears to be blowing air into the bathroom rather than pulling air from the bathroom. Recommend repairing or replacing.

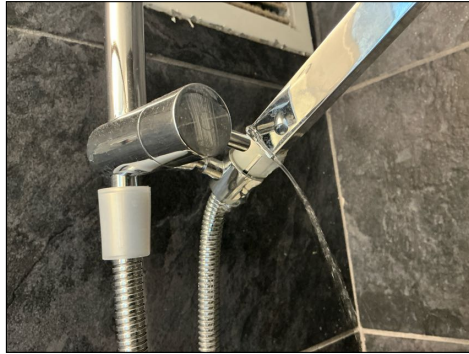
Shower head leaks when tested. Recommend repair.

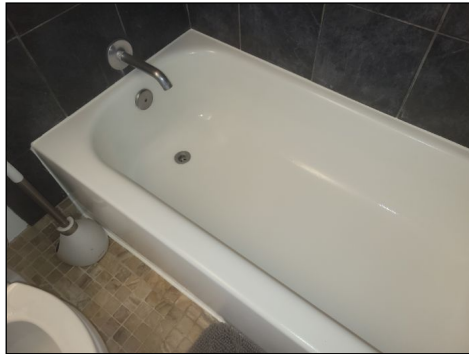
(REVISION.01APR2026) The bathtub has been repaired & glazed. The bathtub is in good condition.

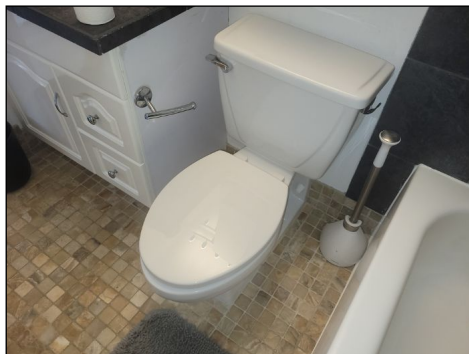
(REVISION.01APR2026) The toilet has been repaired. The toilet was tested & is in good condition.

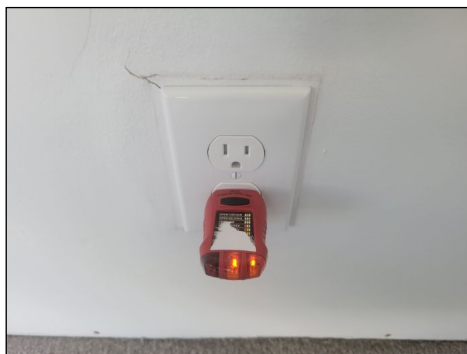
(REVISION.01APR2026) The outlets have been replaced. The outlets were tested & are in good condition.

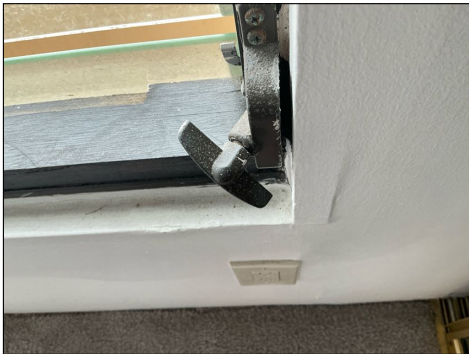
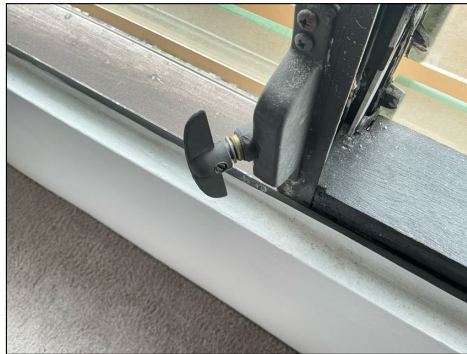
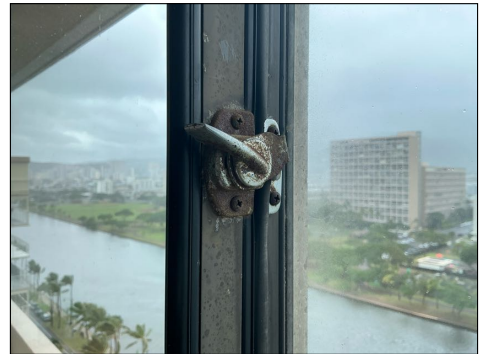
Broken window handles observed. The window should be considered aged than worn. We recommend any necessary maintenance, cleaning & minor repairs to ensure that the windows remain in optimal condition.

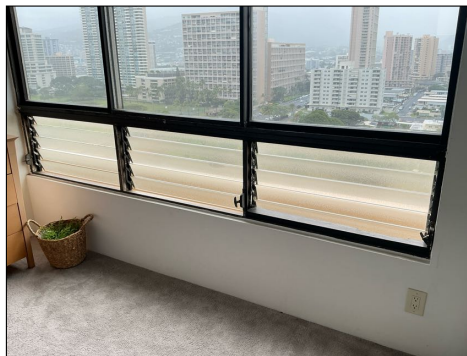
Missing window screens. Recommend installing.

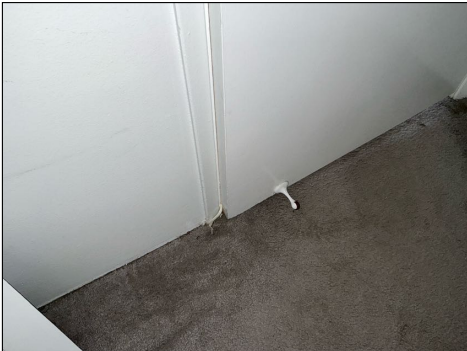
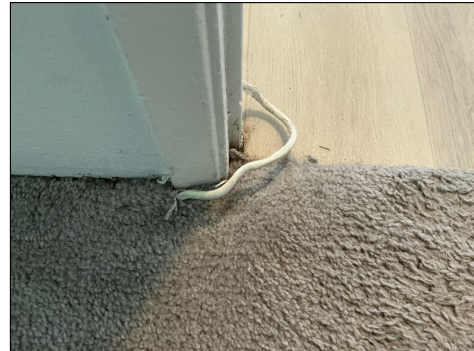
There is a media cable running through the doorway. The door does not close properly. Recommend repair.

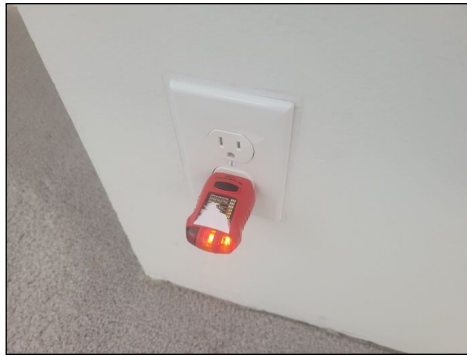
(REVISION.01APR2026) The outlets have been replaced. The outlets were tested & are in good condition.

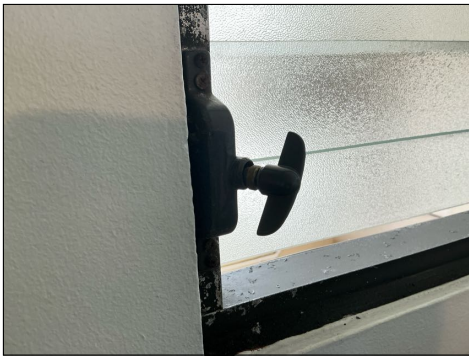
Broken window handle observed. The windows should be considered aged & worn. We recommend any necessary maintenance, cleaning & minor repairs to ensure that the windows remain in optimal condition.

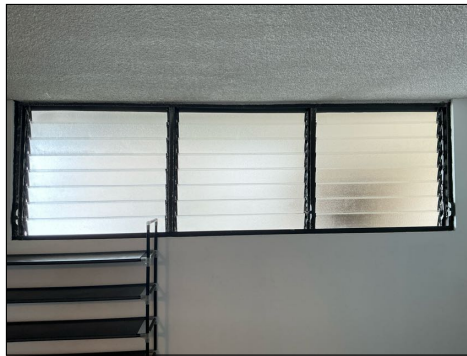
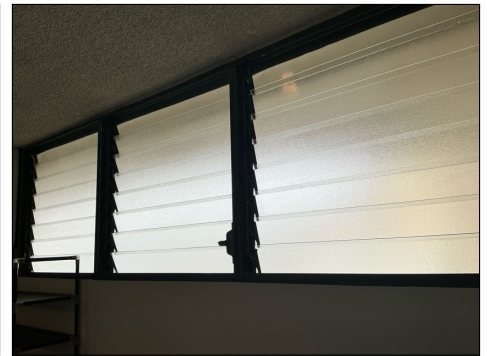
Missing window screens. Recommend installing window screens.

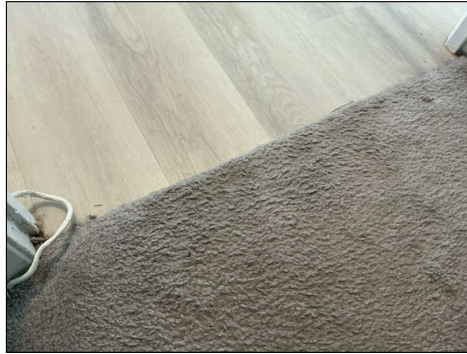
Carpet fasteners are loose & exposed in multiple areas throughout the home. (Carpet fasteners will poke your foot when stepped on.) Recommend necessary repairs to prevent injury.

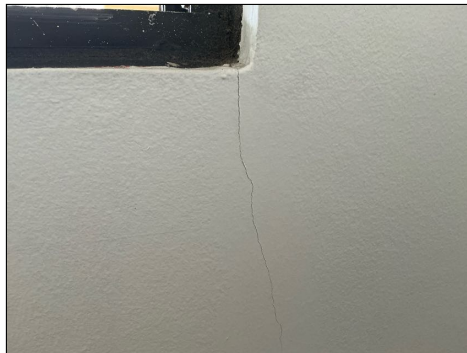
Hairline fracture observed along the wall below the window. This may be considered cosmetic damage. Recommend repair repairs by a qualified professional.

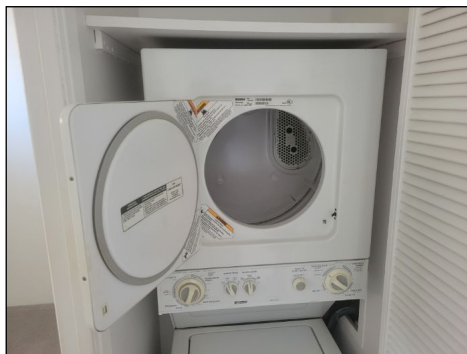
- The dryer does not appear to function properly. When tested, the dryer does not appear to turn or move. Recommend repairing or replacing.

(REVISION.01APR2026) Maintenance was performed on the dryer. The dryer was tested & is in good condition. We recommend routine maintenance & cleaning to ensure the dryer remains in optimal condition.

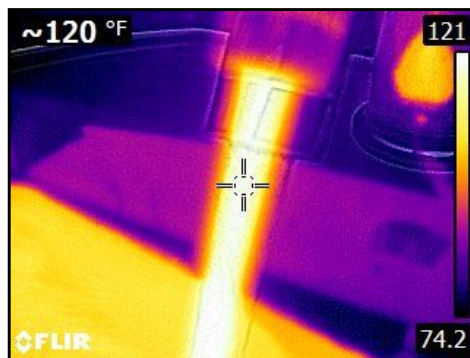
Hot water at 120 degrees and within normal range.

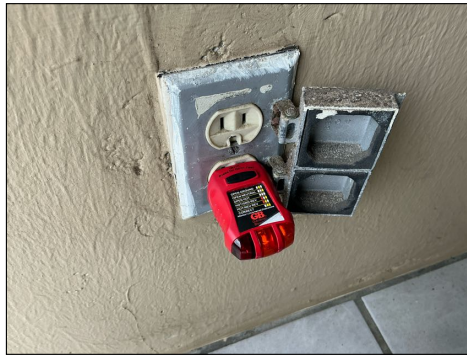
The balcony is not equipped with a GFCI safety outlet. Recommend installing GFCI outlets for safety purposes.

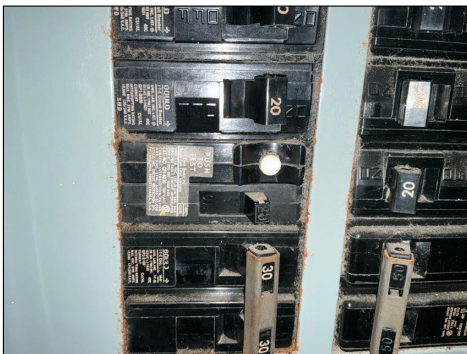
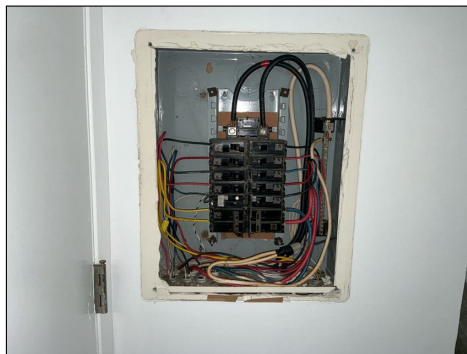
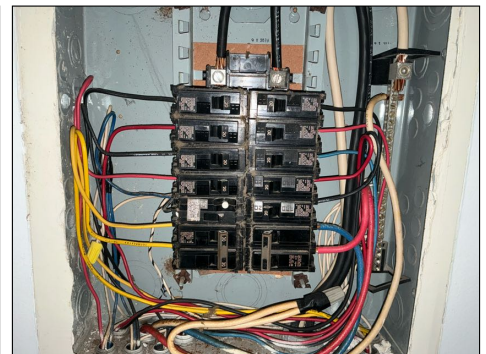
\*\*\*\*Safety Concern\*\*\*\* GFCI breaker did not respond to a self diagnostic test. Recommend repairing or replacing.

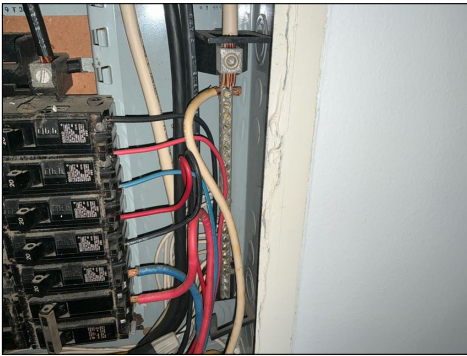
The breaker panel appears to be aged. The building was built during a time when the breaker panel did not require an independent ground bus bar. Current electrical requirements recommend that the breaker panel be equipped with two separate bus bars for the ground & neutral wires. Recommend a further evaluation by a licensed electrician to discuss necessary repair options.

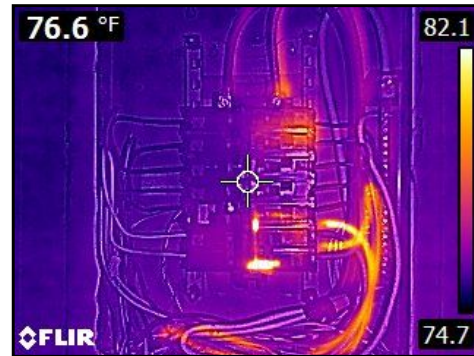
Infrared scan shows normal condition; no overheating.
